Aquifer Breach FAQ

Aquifer Breach

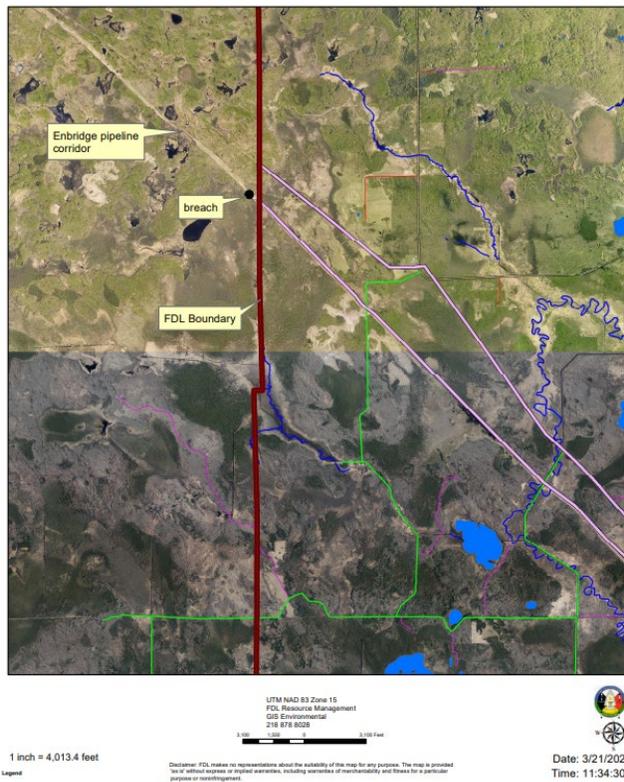
The area where the uncontrolled groundwater flow is occurring is located south of US Highway 2 and east of Minnesota Highway 73 in St. Louis County, Minnesota, approximately 400 feet west of the FDL Reservation boundary. However, the aquifer is discharging its water content within the boundaries of the Reservation upstream of Deadfish Lake (see map).
